Gigli, G. and Frodella, W. and Mugnai, F. and Tapete, D. and Cigna, F. and Fanti, R. and Intrieri, E. and Lombardi, L. (2012) 'Instability mechanisms affecting cultural heritage sites in the Maltese Archipelago.', *Natural hazards and earth system sciences.*, 12 (6). pp. 1883-1903.

Instability mechanisms affecting cultural heritage sites in the Maltese Archipelago

G. Gigli¹, W. Frodella¹, F. Mugnai¹, D. Tapete¹, F. Cigna^{1,*}, R. Fanti¹, E. Intrieri¹, and L. Lombardi¹

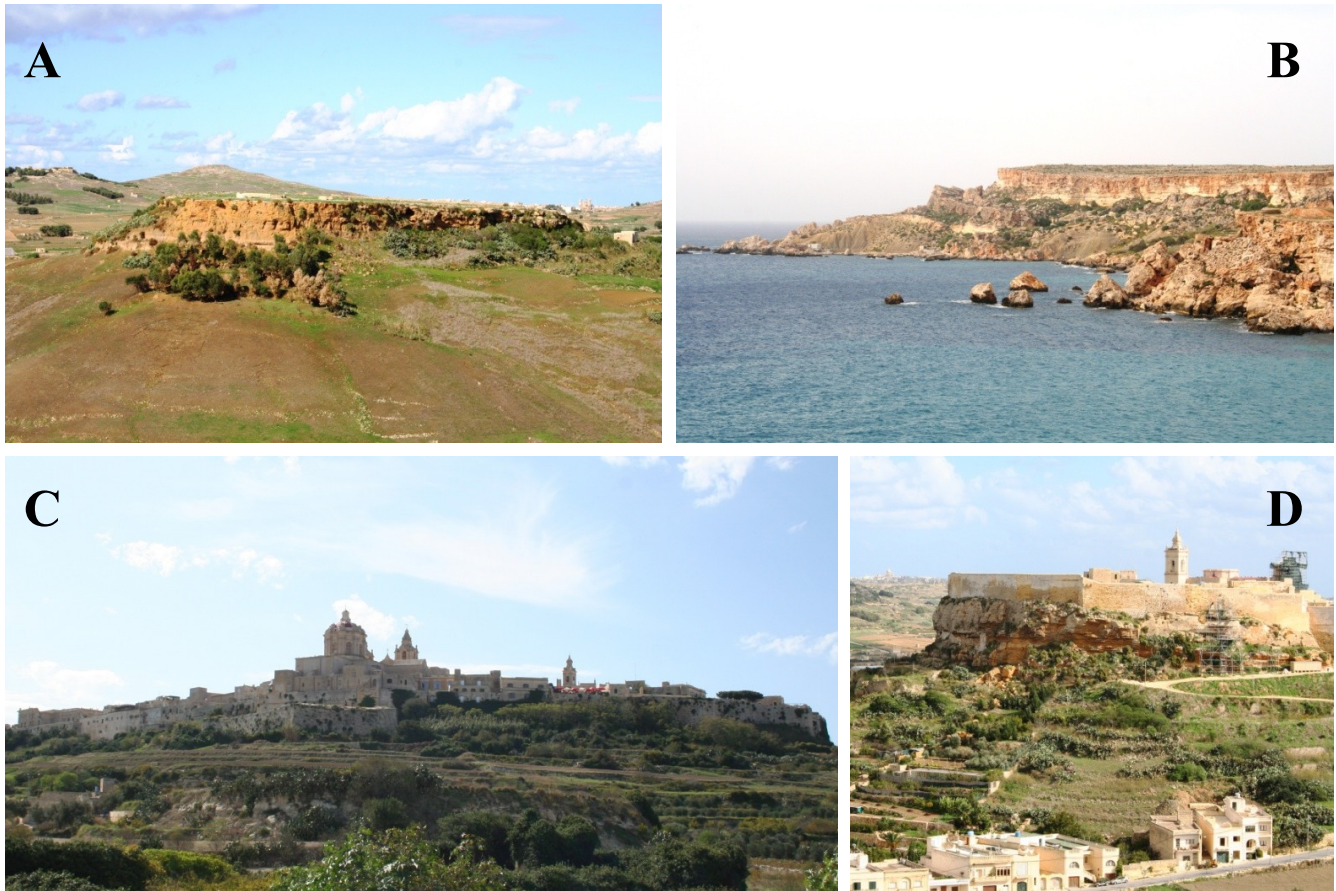
Fig. 3. Panoramic views of UCL slabs overlying BC exposed in Gozo (A) and Malta (B), and of the investigated sites of Mdina (C) and Citadel (D).

UCL hillcaps and plateaus overtopping BC gentle slopes are the dominant feature in the landscape of north-western Malta and north-eastern Gozo (Fig. 3a, b). Therefore, the geological and geomorphological features of the latter areas are deeply influenced by the geological characteristics and mutual interaction of the above-mentioned formations (Magri et al., 2008; Devoto et al., 2011), while GS, due to its limited thickness, can only affect the form of the land surface locally.

stability. Furthermore rainfall washes away the easily erodible BC causing the overtopping limestone caps to break away and collapse into blocks of various sizes (Fig. 3d) (Pedley et al., 2002).

Mdina, the former capital of Malta, is a fortified town located in the central – western sector of the Island on a rise constituted by the UCL (Fig. 3c). Thanks to its strategic position, over the past centuries the city has been influenced by many cultures. In 1693 it was extensively damaged by the Val di Noto (Sicily) earthquake (Galea, 2007), and most of the buildings and bastions were constructed afterwards (De Lucca, 1993). The city is built on a thin UCL plate (maximum thickness: 6 m) with a rhomboidal shape and a total surface area of about 55 000 m².

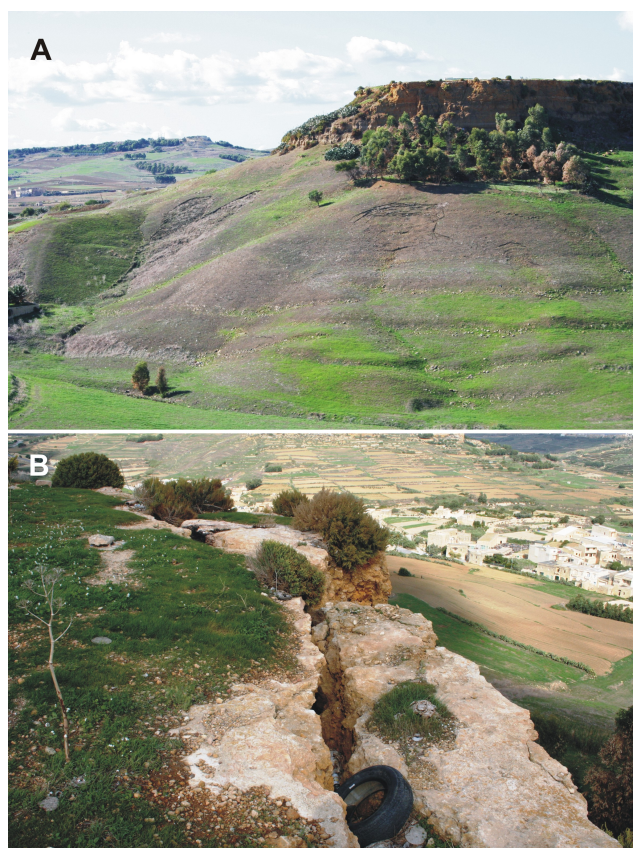
Fig. 17. Field validation of the numerical modelling results. (A): General view of the Gelmus Hill, close to Citadel; (B): Detail of the outer portion of the rock mass.
